PRO-SERVIS

Održavanje srednjenaponske i
niskonaponske opreme

Održavanje SN i NN opreme

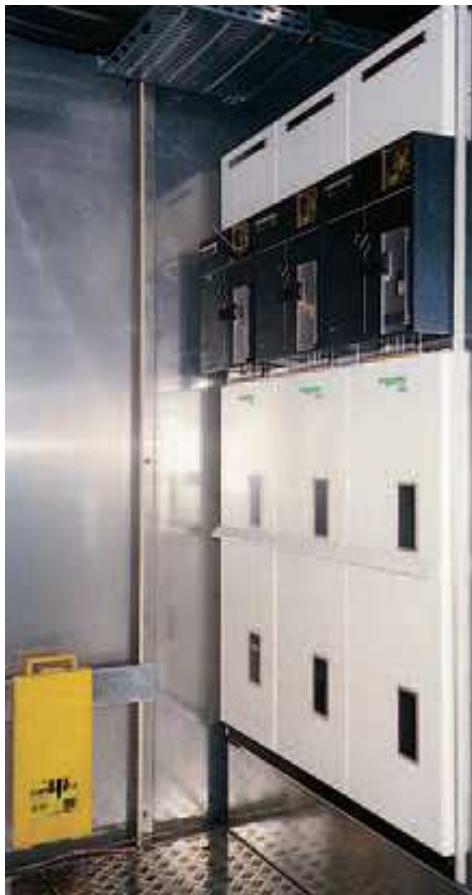
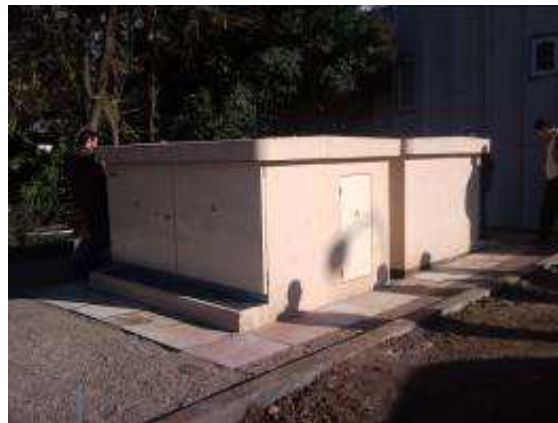
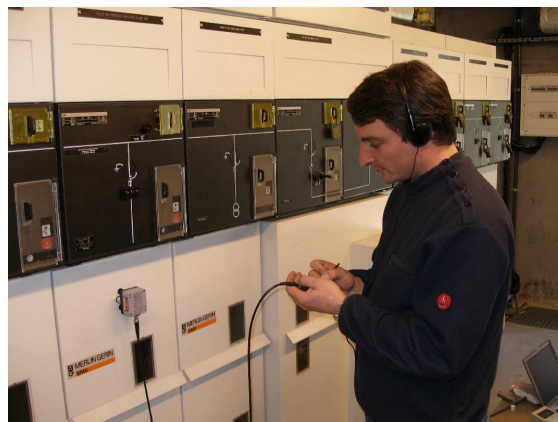
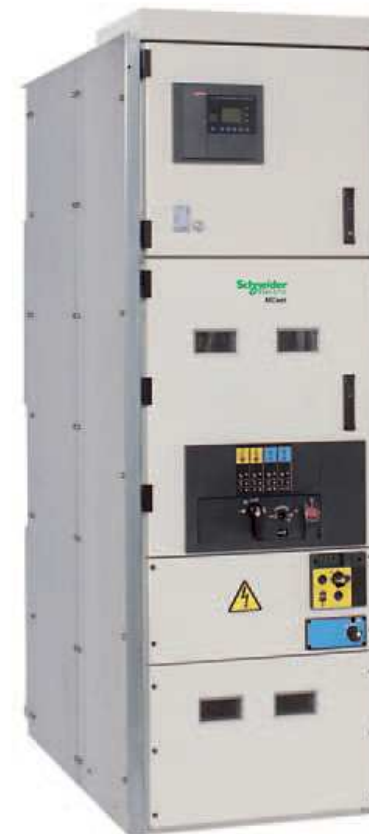
4. ProCorona – ispitivanje opreme preko kućišta na efekat Korone

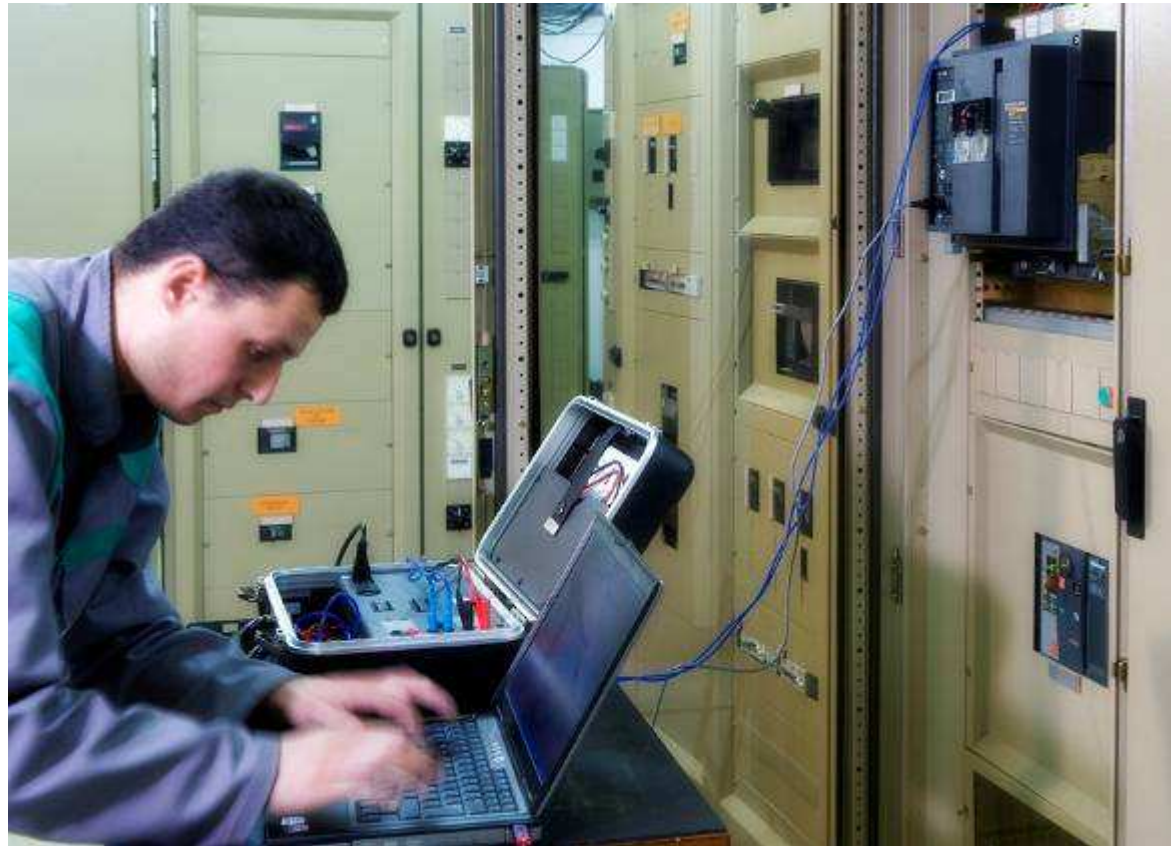
- a. Masterpact NW i NT
- b. Compact

- **Šta se ispituje:** ProSelect je alat za proveru selektivnosti okidanja prekidača.
- **Oprema koja se može ispitati:** Moguće je ispitati krive okidanja LV prekidača – Masterpact & Compact sa elektronskom i mikroprocesorskom zaštitom.
- **Uslovi rada:** Beznaponsko stanje.
- **Okvirno vreme ispitivanja po prekidaču:** 0,5h.
- **Skraćenica pregleda:** PS
- **Opis:** Pomoću standardnih ispitnih kofera FFTK (za Masterpact i Compact NS prekidače) i LTU programa sa napojnim modulom (za Compact NSX prekidače) vrši se ispitivanje samih prekidača. Tako generisane vrednosti unose se u ProSelect program kojim se onda generiše selektivnost prekidača za odgovarajuću “granu” potrošača. Tako generisani izveštaji služe za analizu selektivnosti uređaja te se daju sugestije krajnjem korisniku za poboljšanje iste.

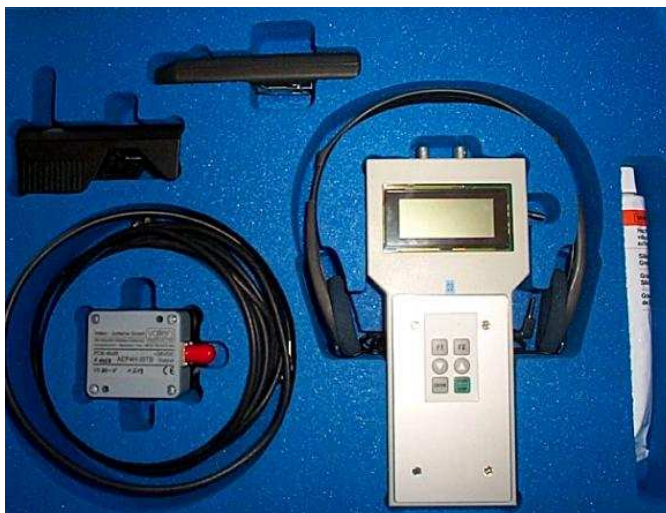
PROCORONA program

- IB opis
- Merenja i snimanje
- Analiza merenja
- Zaključci i preporuke
- Izveštaj

- **Šta se ispituje:** ProCorona je alat za ispitivanje površinskih parcijalnih pražnjenja u SN ćelijama/postrojenjima.
- **Oprema koja se može ispitati:** Moguće je ispitati površinska parcijalna pražnjenja u SN ćelijama/postrojenjima svih proizvođača opreme.
- **Uslovi rada:** Pod naponom.
- **Okvirno vreme ispitivanja po polju:**
- **Skraćenica pregleda:** PC
- **Opis:** ProCorona – om je moguće ispitati površinska parcijalna pražnjenja u SN ćelijama svih proizvođača opreme. Na osnovu generisanog izveštaja moguće je dalje ići na analizu uzroka nastajanja Korone kao i njenog otklanjanja.
- **Napomena:** Vreme snimanja je stvar dogovora između krajnjeg korisnika i Schneider Electric-a, zbog uslova eksploatacije, koji dovode do stvaranja efekta korone!

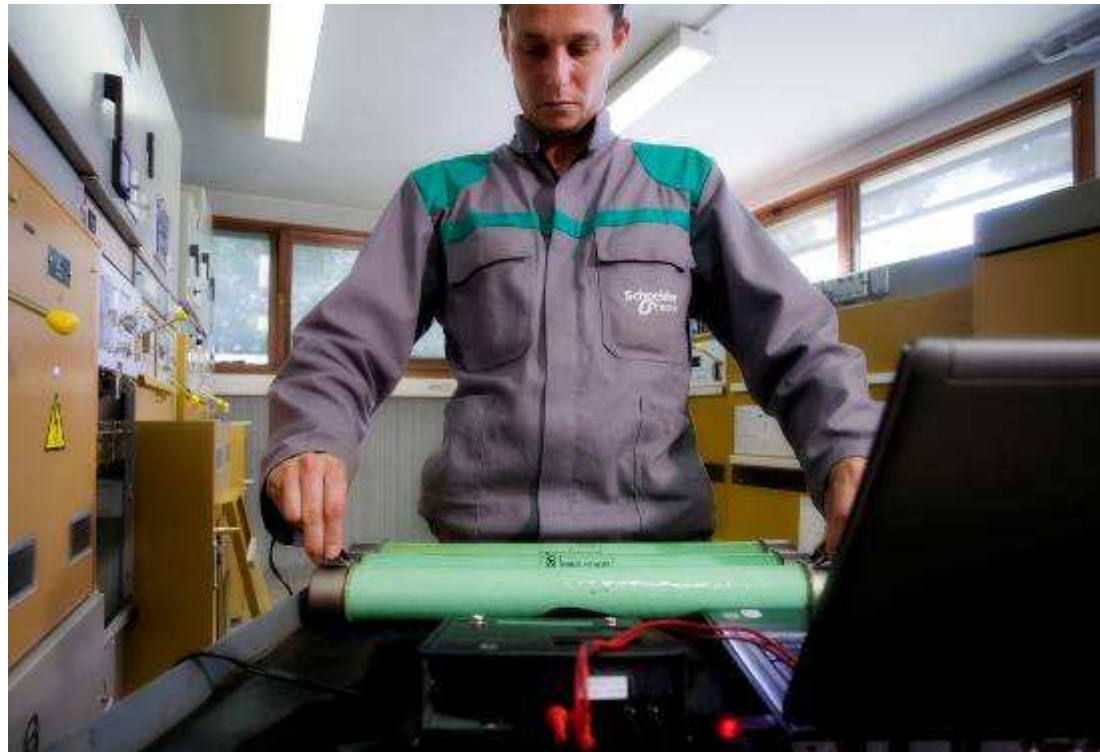
- Merenje otpora na SN osiguraču pomoću miliommetra
- Poređenje dobijenih vrednosti sa vrednostima u bazi ProFusion programa

MV fuses consist of several filaments wound around a ceramic core. Rupture of one or more filaments (due to a shock or overcurrent) will cause the fuse to increase in resistance leading to overheating and possible thermal runaway, degenerating into internal arcing. Fuses must therefore be tested to ensure they are not damaged.
